### **TECHNICAL SERVICE BULLETIN**

| SUBJECT: | | No: <b>TSB-07-42A-007</b> | |
| <b>SUNROOF WATER LEAK</b> | | DATE: <b>March, 2007</b> | |
| | | MODEL: <b>2006-07 Eclipse</b> | |

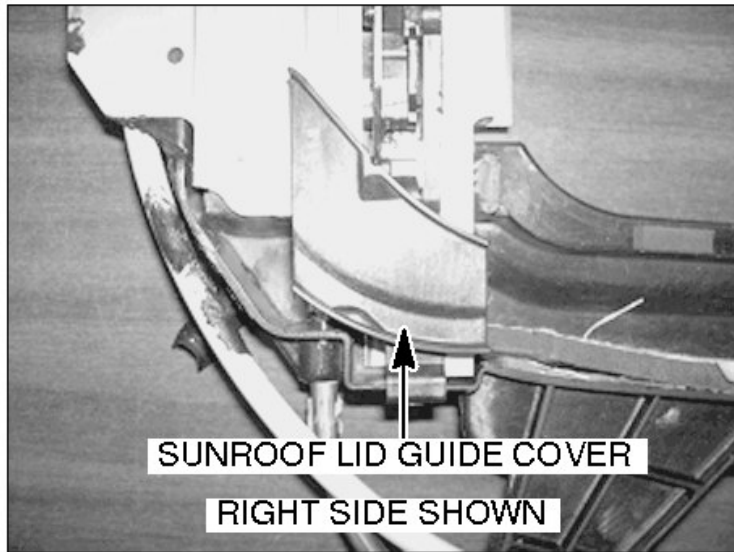
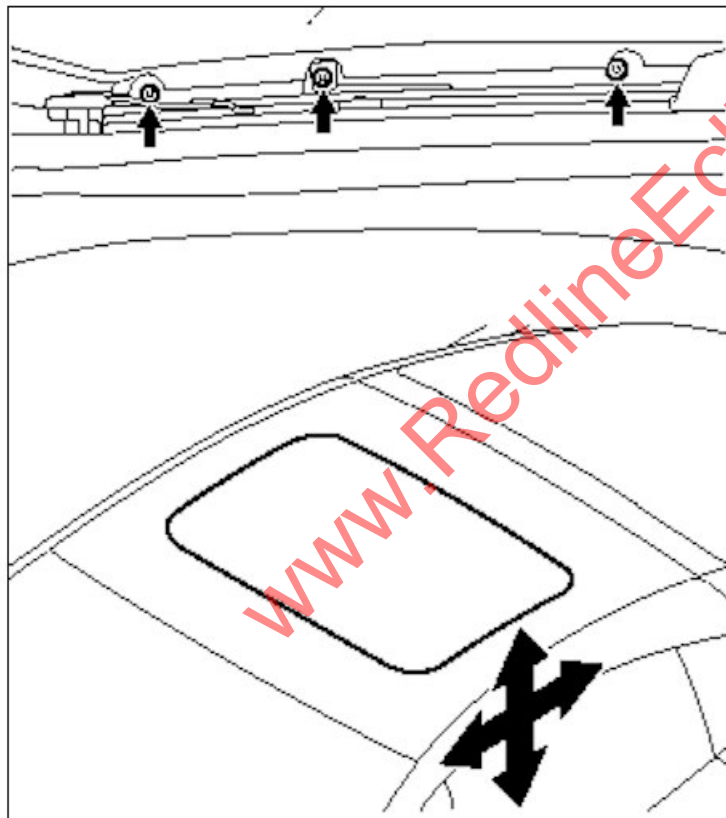
Water leakage may occur due to water getting past the sunroof glass seal. Leakage may be evident from the sunroof switch, or at the SRS logo covers on the 'A' pillar trim. Follow the procedure below to add sunroof lid guide covers to repair this condition.

1. Remove the sunroof glass. Follow the service manual procedure in Group 42A of the appropriate service manual for removal instructions.
2. Remove the headliner. Follow the service manual procedure in Group 52A of the appropriate service manual for removal instructions.
3. Disconnect the four sunroof drain tubes.
4. Remove the complete sunroof assembly from the vehicle and place it onto an appropriate work surface.
5. Clip the left hand and right hand sunroof lid guide cover (listed in the PARTS INFORMATION section of this bulletin) onto each front corner as shown.
6. Reinstall the sunroof assembly into the vehicle.
7. Reattach the four drain tubes. Insure that the tubes are pushed all the way onto the sunroof drain nipples.

8. The glass should be centered in the vehicle and 1 mm below the roof surface along the front edge and flush with the roof surface along the rear edge. If the sunroof glass is not in the proper position, adjust as necessary.
